Report No: RJ6493P-1

SUBJECT: Rain Test on Solar Panel Tile Sleds.

SAMPLE ID: Two each, PEGASUS SOLAR™ Tile Sleds.

TEST REQUESTED: Rain Test per Section 4.1 of ICC ES *Acceptance Criteria for Roof Flashing for Pipe Penetrations*, AC286, Approved October 2012.

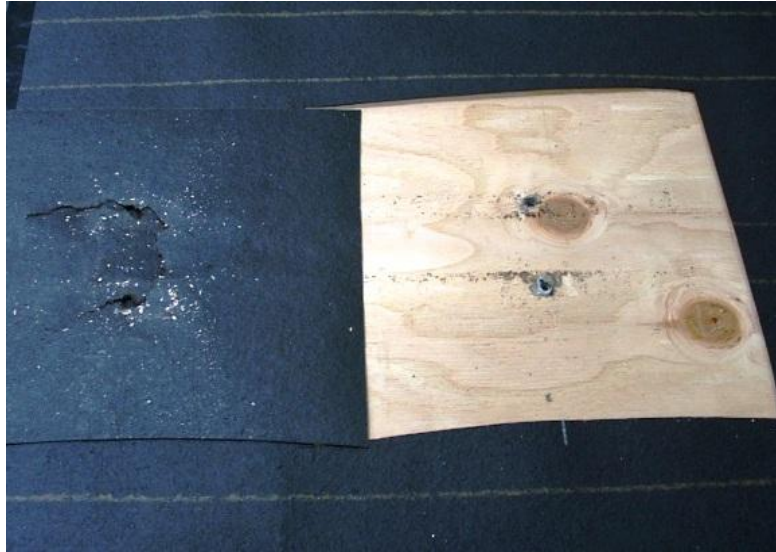
Photograph No.4

Results of Rain Test Conducted on Deck No.1 (2:12 Slope)

No evidence of water penetration was observed through or around the tile sled
or on the underside of the roofing felt

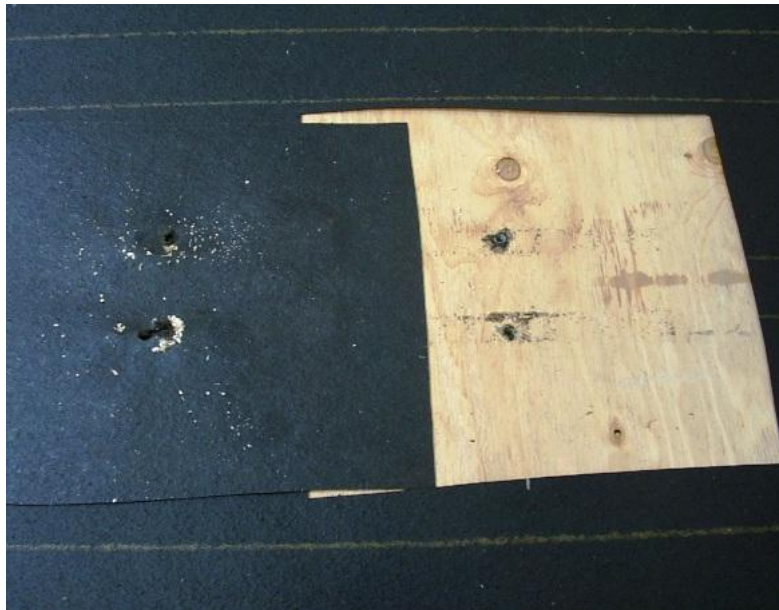
Photograph No.5

Results of Rain Test Conducted on Deck No.1 (9:12 Slope)

No evidence of water penetration was observed through or around the tile sled
or on the underside of the roofing felt

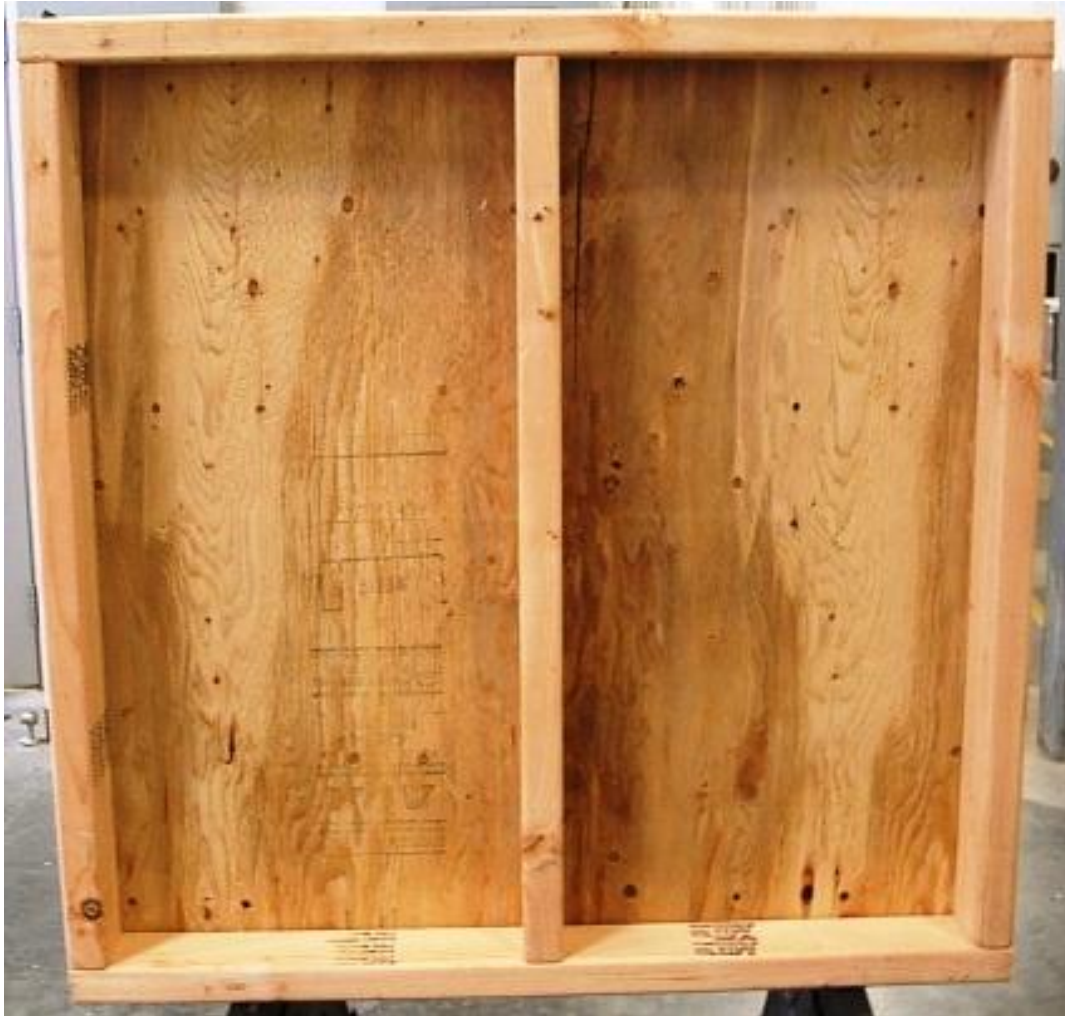
Photograph No.6
Results of Rain Test Conducted on Deck No.1 (2:12 Slope)
No Water Penetration to the Underside of the Roof Deck Occurred.

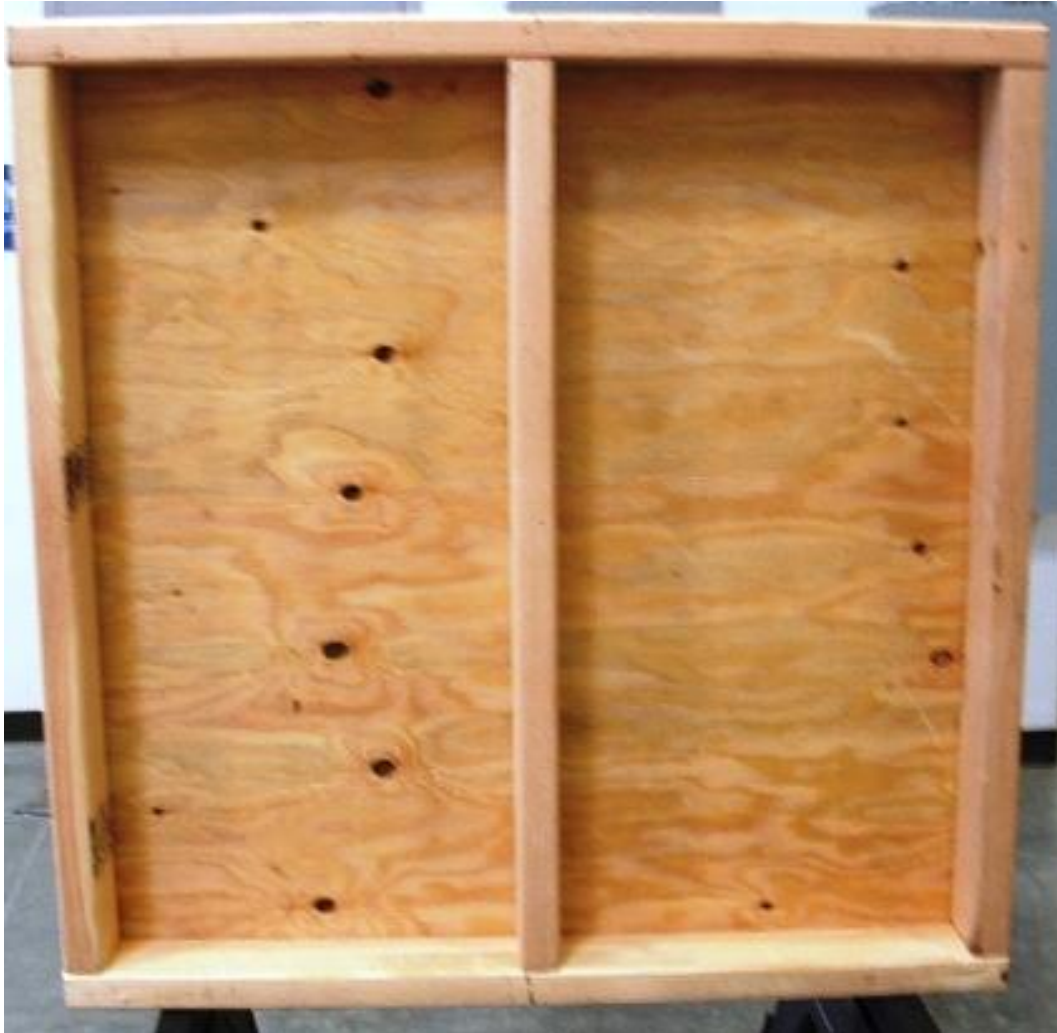
Photograph No.7
Results of Rain Test Conducted on Deck No.2 (9:12 Slope)
No Water Penetration to the Underside of the Roof Deck Occurred.
